**HALL MEADOW BROOK DAM
DAM-BREAK FLOOD
ANALYSIS**

HALL MEADOW BROOK DAM
HOUSATONIC RIVER BASIN
CONNECTICUT

DAM-BREAK FLOOD ANALYSIS
FOR
DEPARTMENT OF THE ARMY
NEW ENGLAND DIVISION, CORPS OF ENGINEERS
WALTHAM, MASSACHUSETTS

BY
VOLLMER ASSOCIATES
6 ST. JAMES AVENUE
BOSTON, MASSACHUSETTS 02116

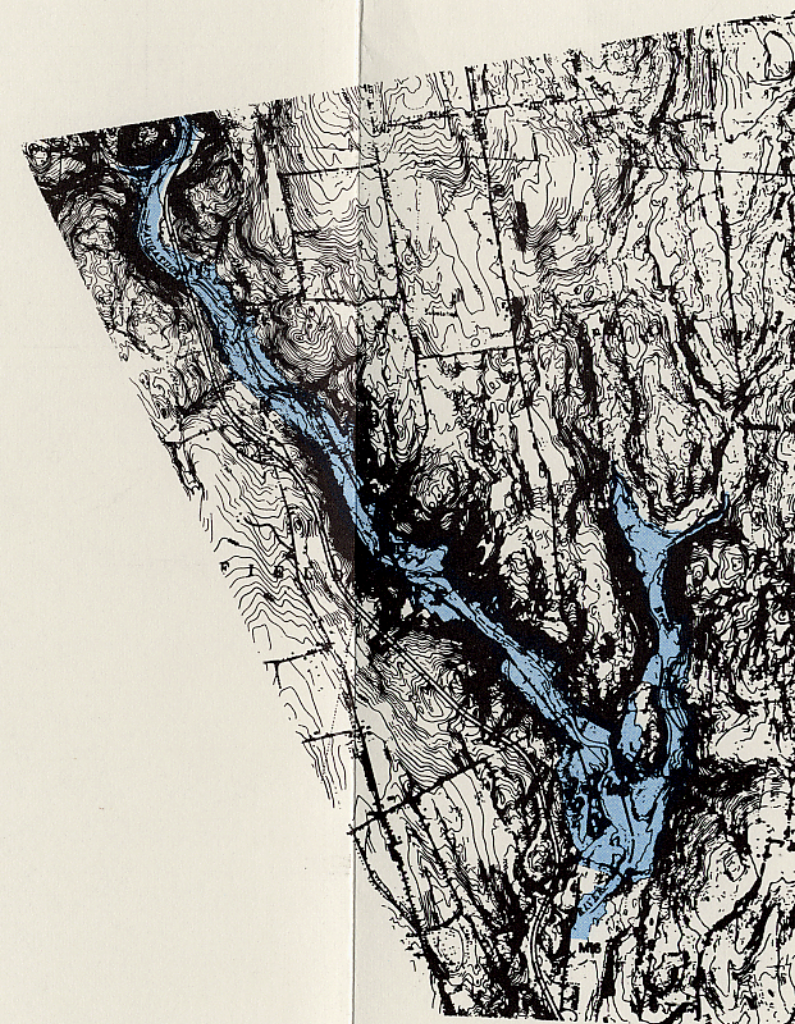
| HOUSATONIC RIVER BASIN NAUGATUCK RIVER WATERSHED HALL MEADOW BROOK DAM BREACH FLOOD PLAN & PROFILE #2 | |

- LEGEND**
- ⊗ EXPERIENCED AUG., 1955 FLOOD ELEVATIONS
 - 1 HOURS FROM START OF FAILURE TO PEAK STAGE
 - 2 HOURS TO INITIAL RIVER RISE
 - +MI RIVER MILES DOWNSTREAM FROM
 - LIMITS OF BREACH FLOOD

The resulting peak stage flood profile and the areal extent of inundation for the base flood conditions is shown on Plates 5 and 6. Timing of the peak stage and leading edge of the flood wave are also indicated on the plan and profile. Peak discharge throughout the study reach associated with the development of the peak stage profile along with discharge and stage hydrographs for four stations downstream from Hall Meadow Brook Dam are shown on Plate 7. The stations are located .02, 2.77, 6.02 and 15.57 miles downstream from the dam.
